NHTSA NEW VEHICLE ASSESSMENT AND
STANDARDS ENFORCEMENT INDICANT TESTING

FMVSS 212, 219, 301
GENERAL MOTORS
1983 CHEVROLET CAPRICE CLASSIC
4-DOOR SEDAN

NHTSA NO. CD0104
CALSPAN TEST NO. 7103-V-3

FEBRUARY 1983

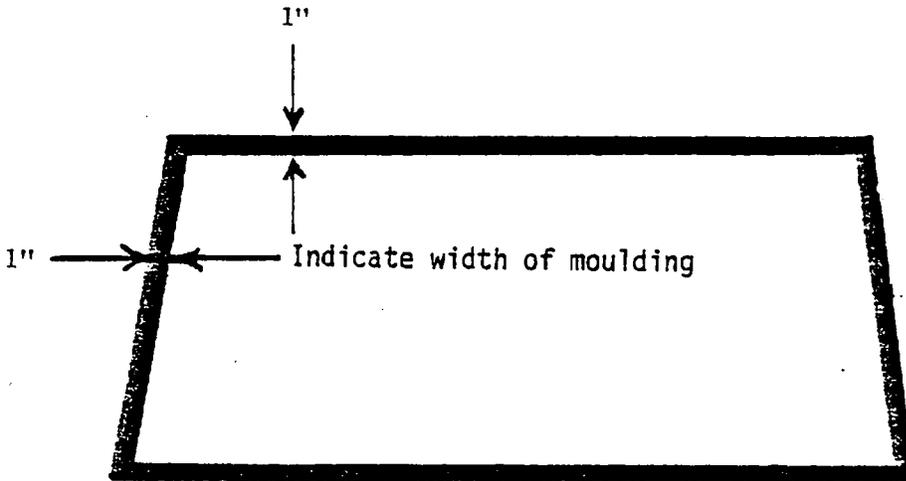
Figure 1 WINDSHIELD RETENTION, FMVSS NO. 212 DATA

AREA OF RETENTION FAILURE

FRONT VIEW

The standard requires that Post-Test be a minimum of 75 percent of the Pre-Test total periphery measurement for vehicle not equipped with occupant passive restraints and 50 percent for each side of the windshield for vehicles which are equipped with occupant passive restraints.

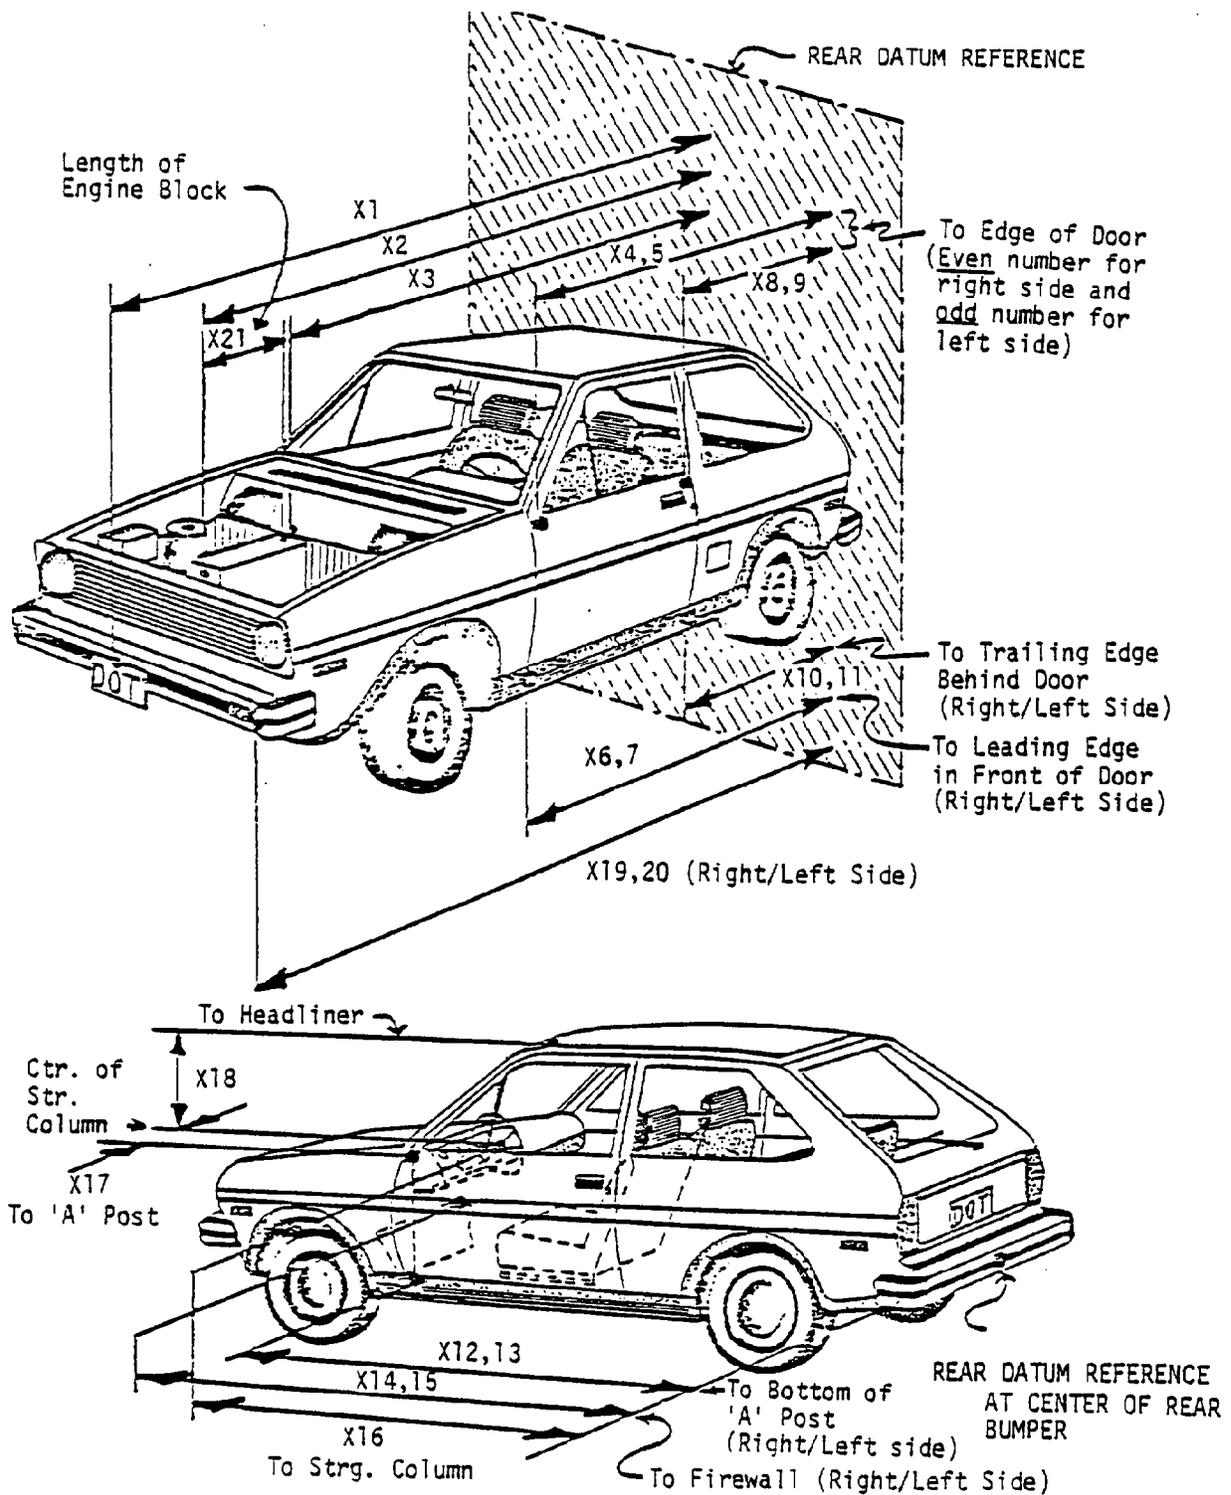
Figure 4 PRE- AND POST-TEST MEASUREMENT POINTS

No.	1983 Chevrolet Caprice Classis	All Dimensions in Inches		
		Pre-Test	Post-Test	Difference
X1	Total Length of Vehicle at Centerline	211.6	183.2	28.4
X2	Rear Surface of Vehicle to Front of Engine	175.6	169.5	6.1
X3	Rear Surface of Vehicle to Firewall	152.7	146.5	6.2
X4	Rear Surface of Vehicle to Upper Leading Edge of Right Door	139.5	139.1	.4
X5	Rear Surface of Vehicle to Upper Leading Edge of Left Door	139.6	139.3	.3
X6	Rear Surface of Vehicle to Lower Leading Edge of Right Door	143.7	144.0	-.3
X7	Rear Surface of Vehicle to Lower Leading Edge of Left Door	143.7	143.2	.5
X8	Rear Surface of Vehicle to Upper Trailing Edge of Right Door	100.2	100.0	.2
X9	Rear Surface of Vehicle to Upper Trailing Edge of Left Door	100.3	100.2	.1
X10	Rear Surface of Vehicle to Lower Trailing Edge of Right Door	101.0	101.3	-.3
X11	Rear Surface of Vehicle to Lower Trailing Edge of Left Door	101.2	101.2	0
X12	Rear Surface of Vehicle to Bottom of "A" Post of Right Side	142.9	142.8	.1

X13	Rear Surface of Vehicle to Bottom of "A" Post of Left Side	142.9	142.4	.5
X14	Rear Surface of Vehicle to Firewall, Right Side	149.5	145.7	3.8
X15	Rear Surface of Vehicle to Firewall, Left Side	151.2	143.2	8.0
X16	Rear Surface of Vehicle to Steering Column	124.8	125.5	-.7
X17	Center of Steering Column to "A" Post	18.1	16.9	1.2
X18	Center of Steering Column to Headliner	17.8	19.7	-1.9
X19	Rear Surface of Vehicle to Right Side of Front Bumper	207.2	182.2	25.0
X20	Rear Surface of Vehicle to Left Side of Front Bumper	207.3	183.3	24.0
X21	Length of Engine Block	18.9	18.9	0

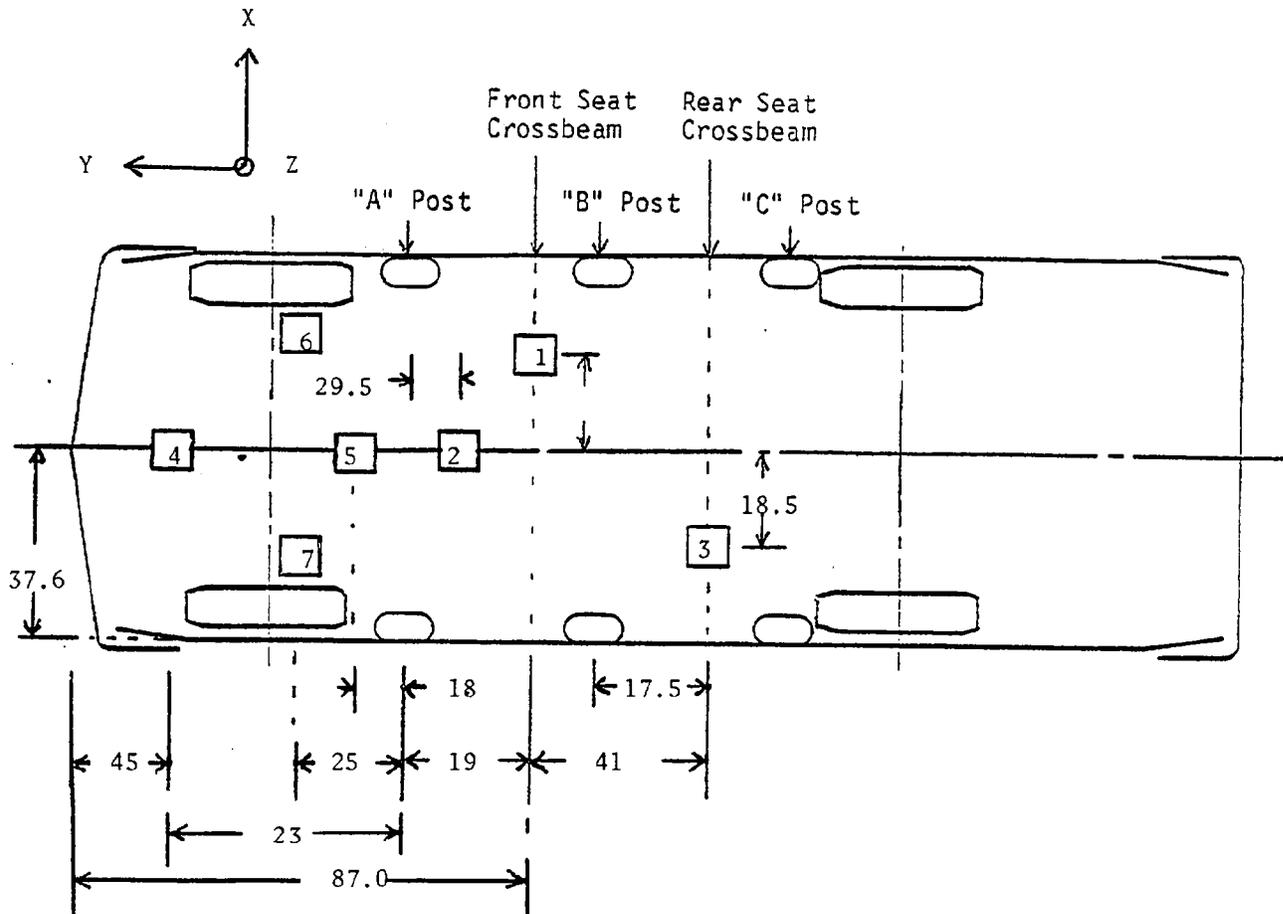
ACCELEROMETER NUMBER *	ACCELEROMETER LOCATION	DIRECTION		
		X	Y	Z
1	Front Seat Crossmember	X		
2	Vehicle C.G.	X		
3	Rear Seat Crossmember	X		
4	Top of Engine	X		
5	Bottom of Engine	X		
6	Right Front Brake Caliper	X		
7	Left Front Brake Caliper	X

*The accelerometer pack number can be correlated with the vehicle response data traces found in Appendix B.

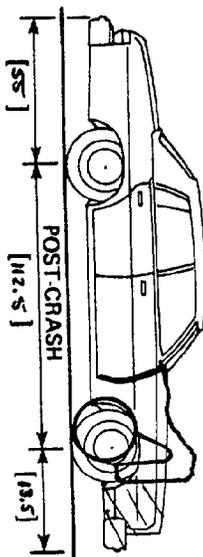
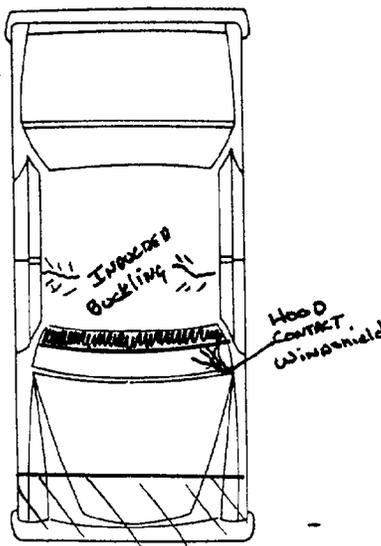
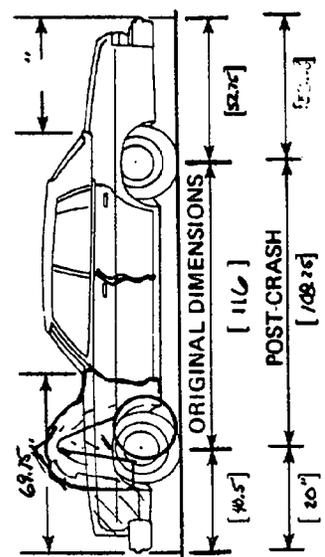
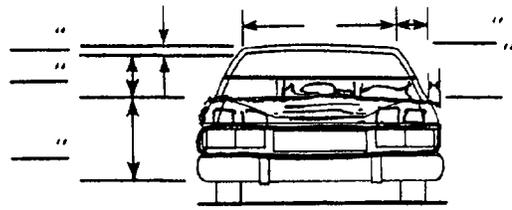
OAL Pre-test = 211.6
 " Post " = 183.2
 MAX. CRASH = 28.4

① RF & LF Doors Jammed
 Closed Ryled open.
 ② Both Doors Window Traces Broken.

Note: Hood Removed Prior to inspection

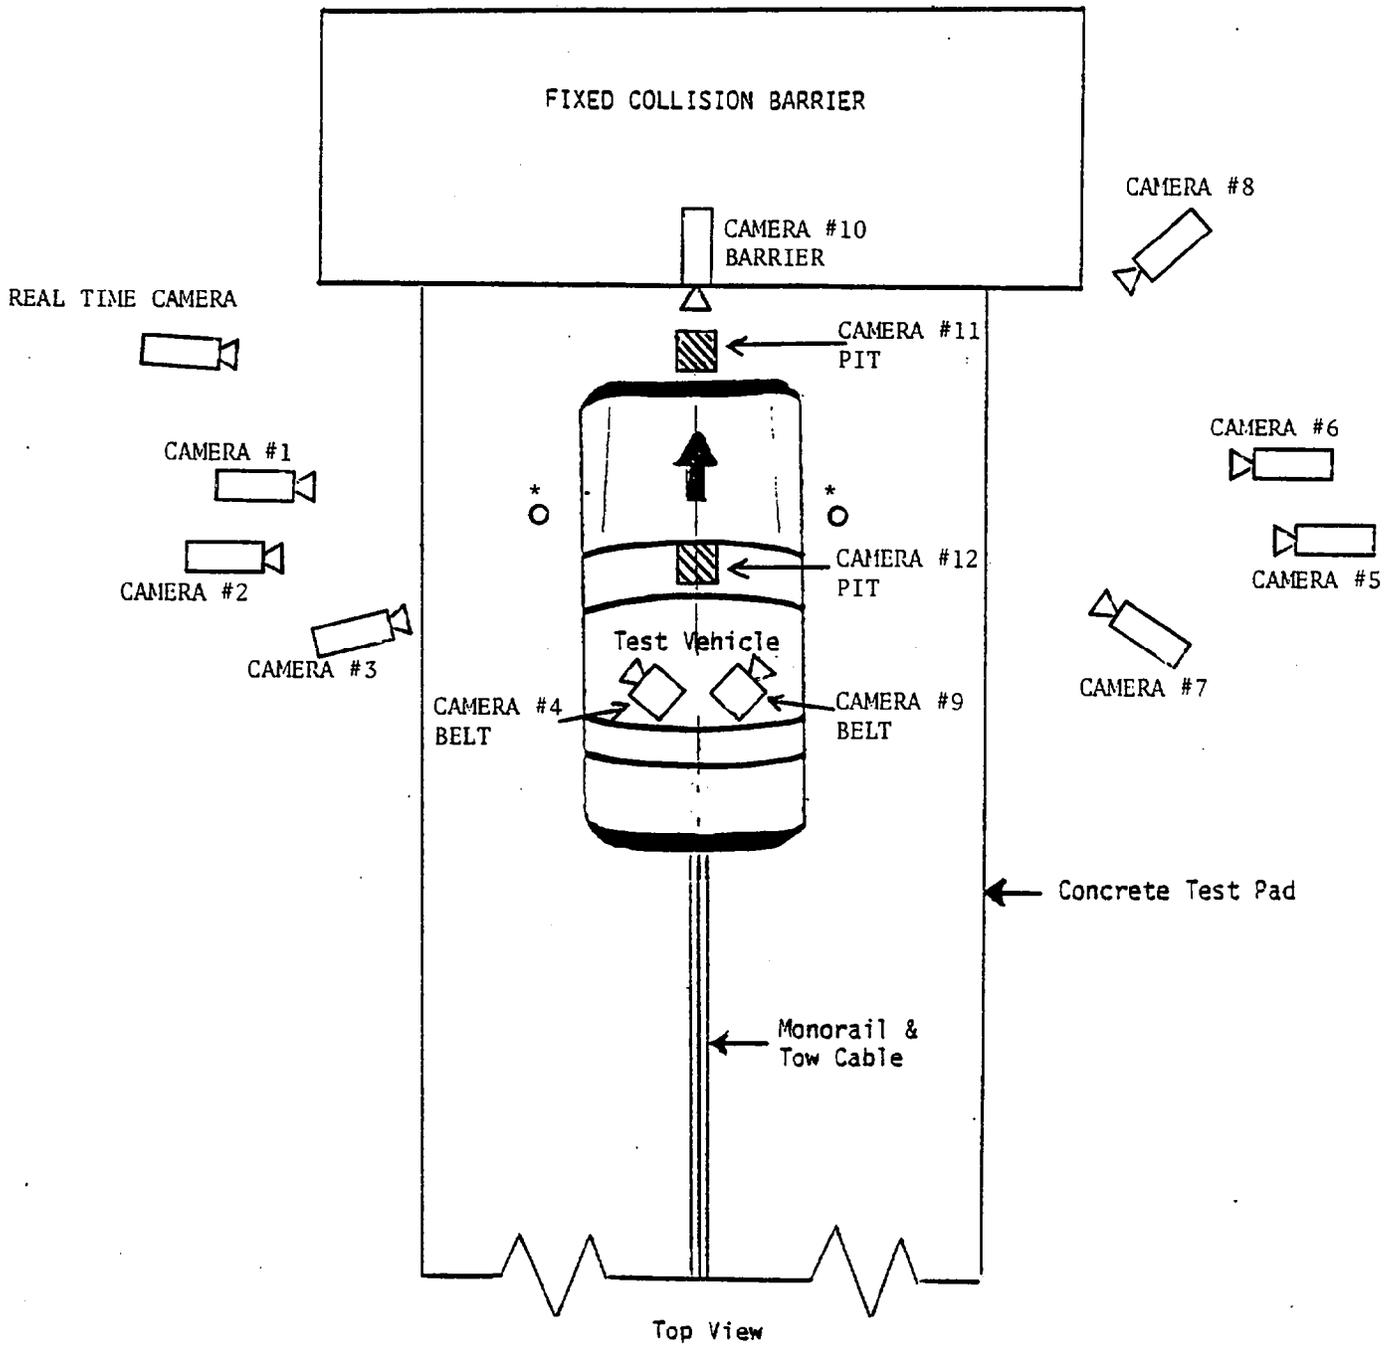
Figure 8 CAMERA POSITION FOR FRONTAL IMPACTS

*Stadia Pole 72" from Barrier Face

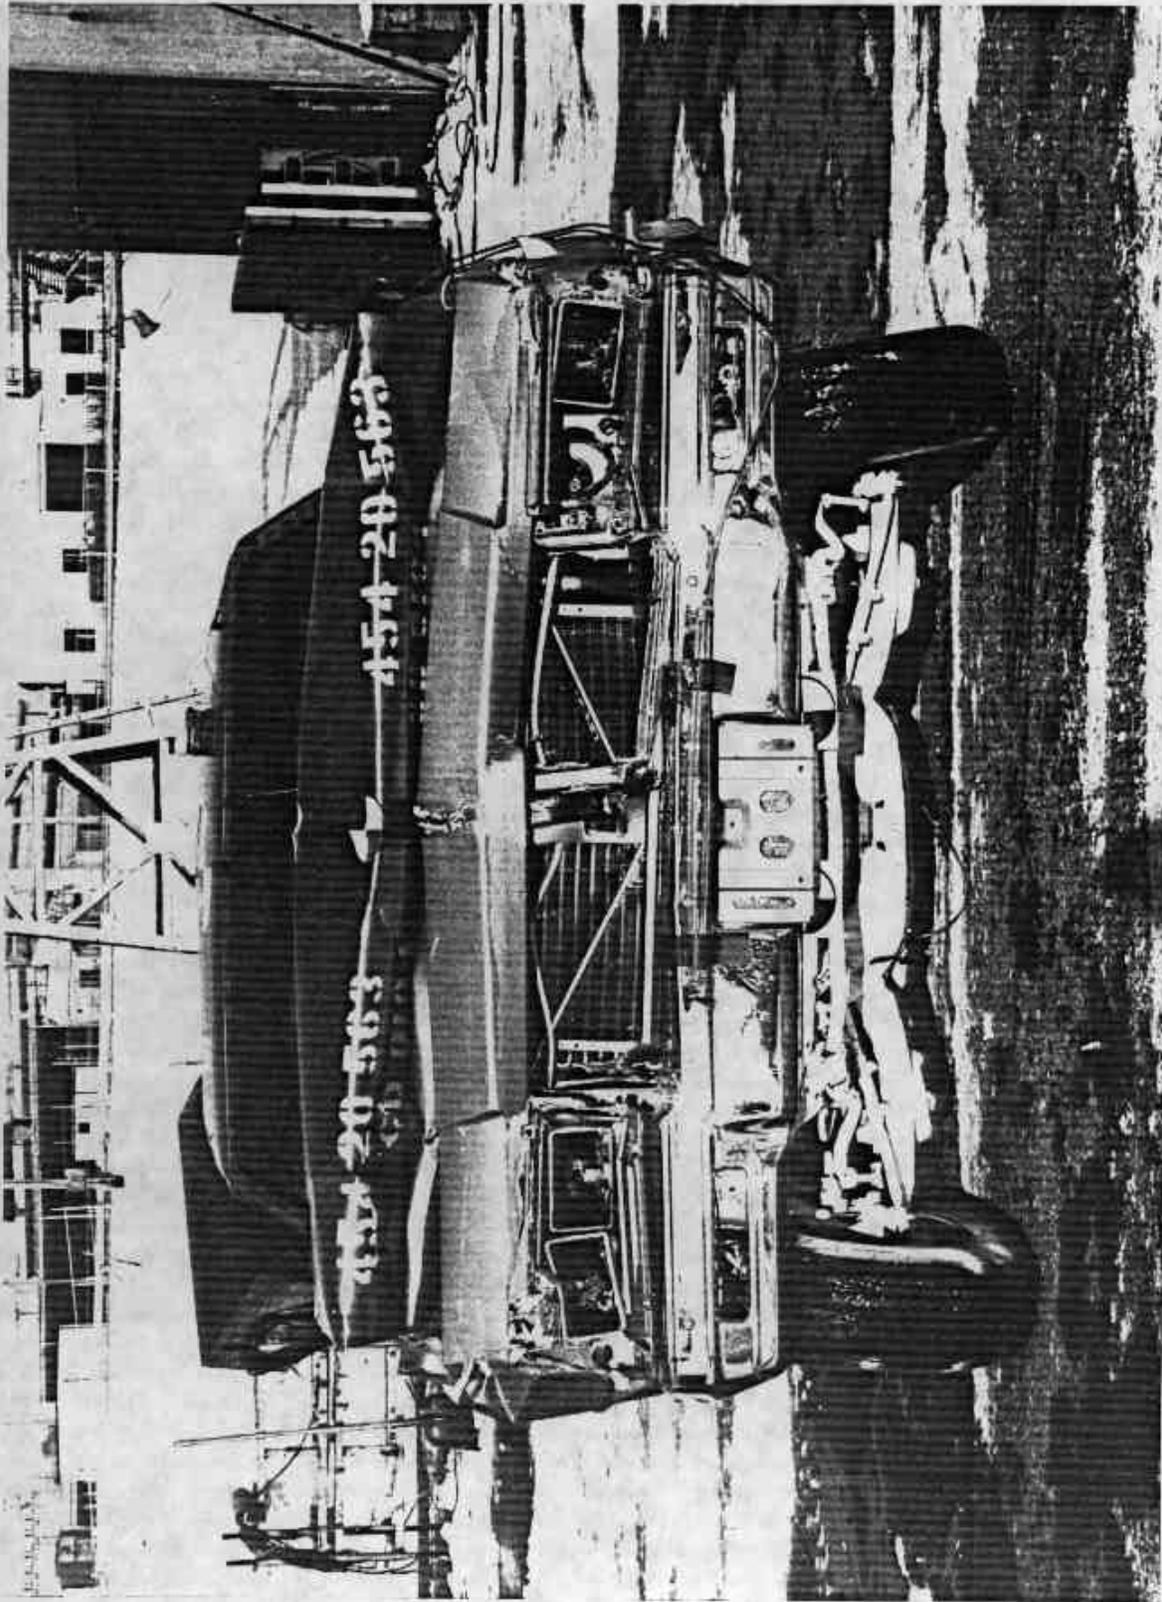
FIGURE A-2 POST-TEST FRONT VIEW

The vehicle sustained 28.4 inches of static crush and approximately 32 inches of dynamic crush. Maximum firewall intrusion into the occupant compartment was 8 inches. The maximum load cell barrier force measured by the 36 load cells was 105,000 pounds at 20 milliseconds. A second force peak of 104,000 pounds was recorded at 57.5 milliseconds.

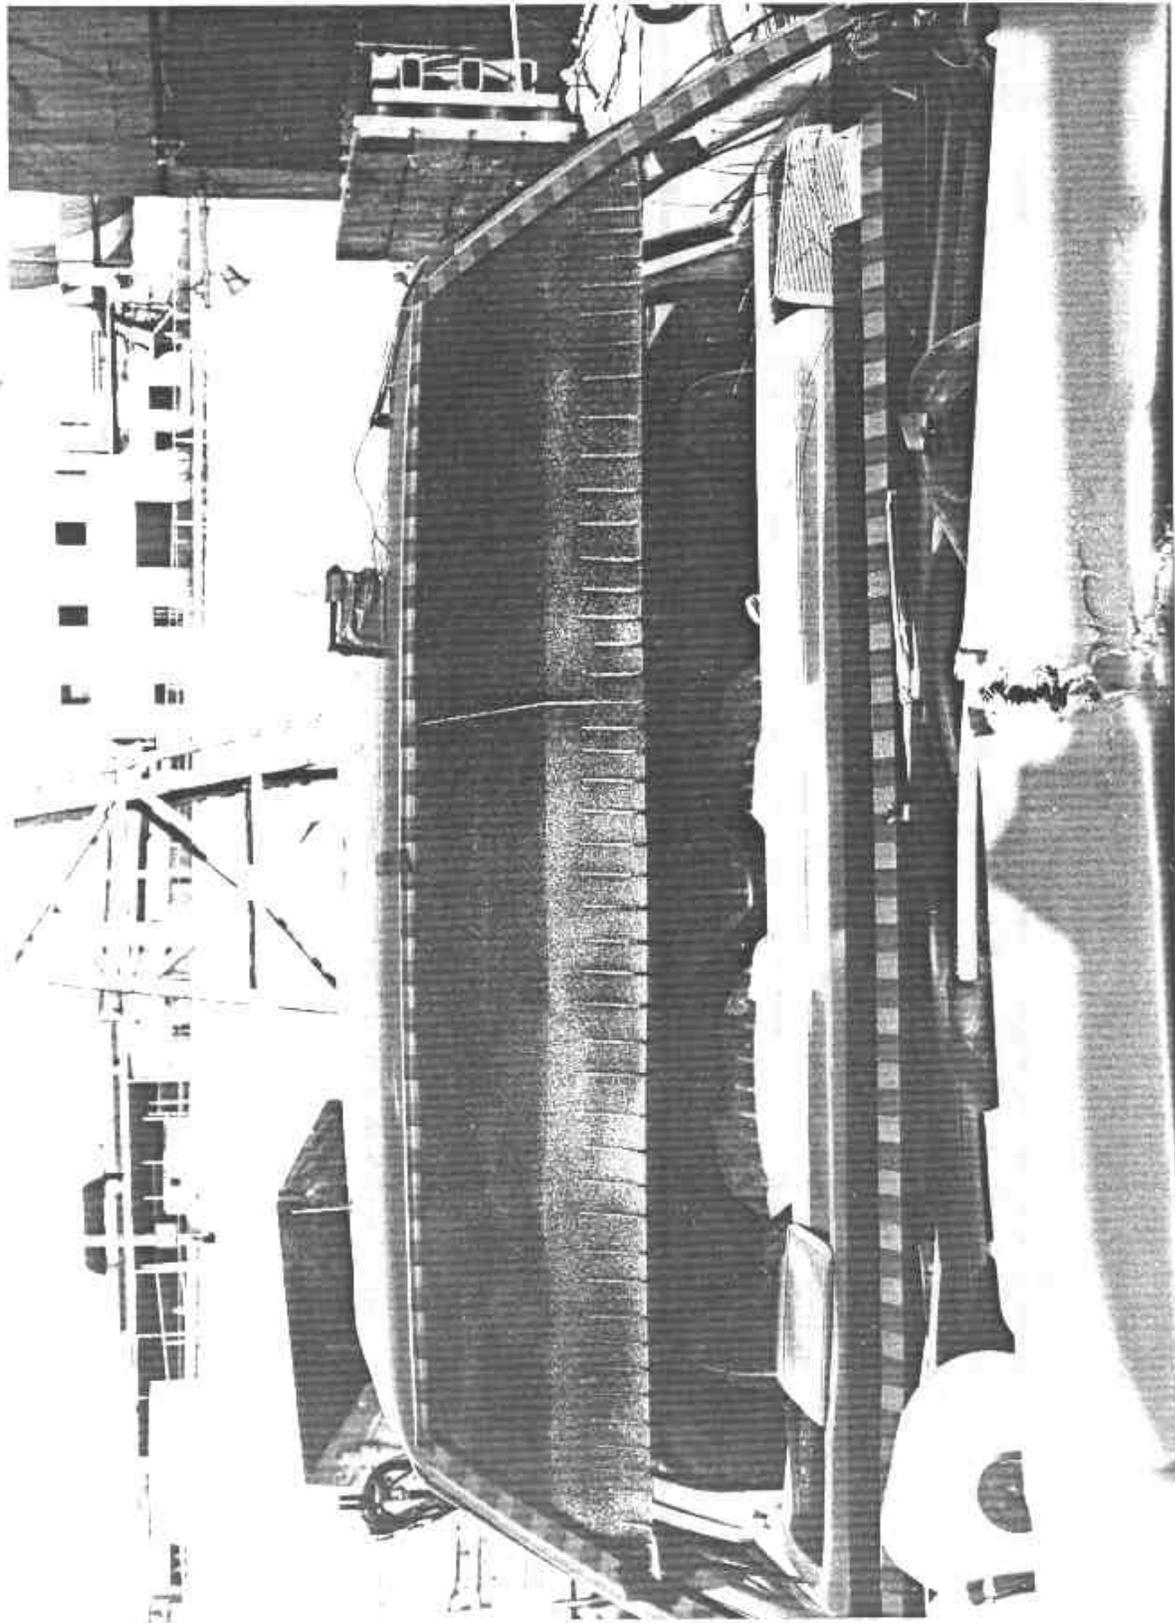
FIGURE A-13 POST-TEST VIEW OF WINDSHIELD AND TEMPLATE

At impact the windshield cracked on the driver's side lower corner. All other glazing remained intact. Both front doors were operable after impact.

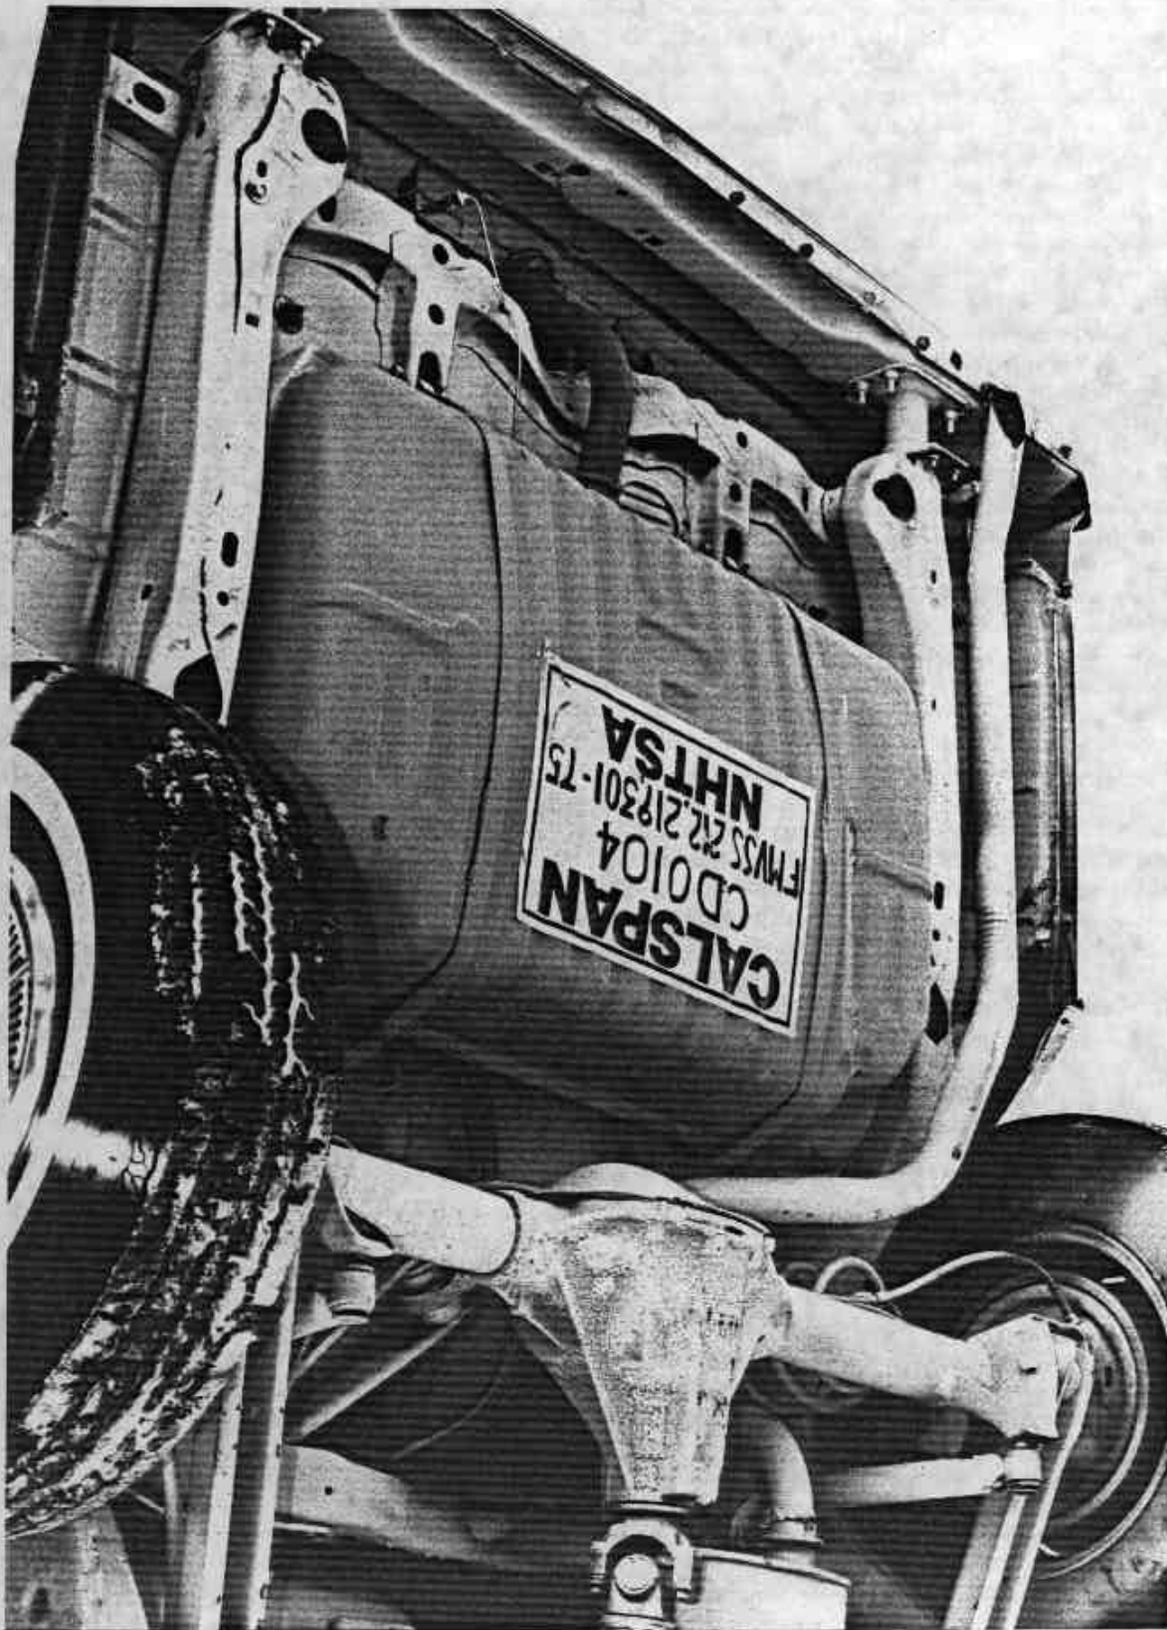
FIGURE A-18 POST-TEST VIEW OF FUEL TANK AND FUEL LINES

The 1983 Chevrolet Caprice Classic which was involved in a frontal load cell barrier crash at a velocity of 35.33 mph appeared to comply with FMVSS Nos. 212 - Windshield Mounting; 219 - Windshield Intrusion; and 301-75 - Fuel System Integrity. There was 100 percent windshield retention, no intrusion into the protected or unprotected zone of the windshield and no fuel leakage after impact or any phase of the rollover test.

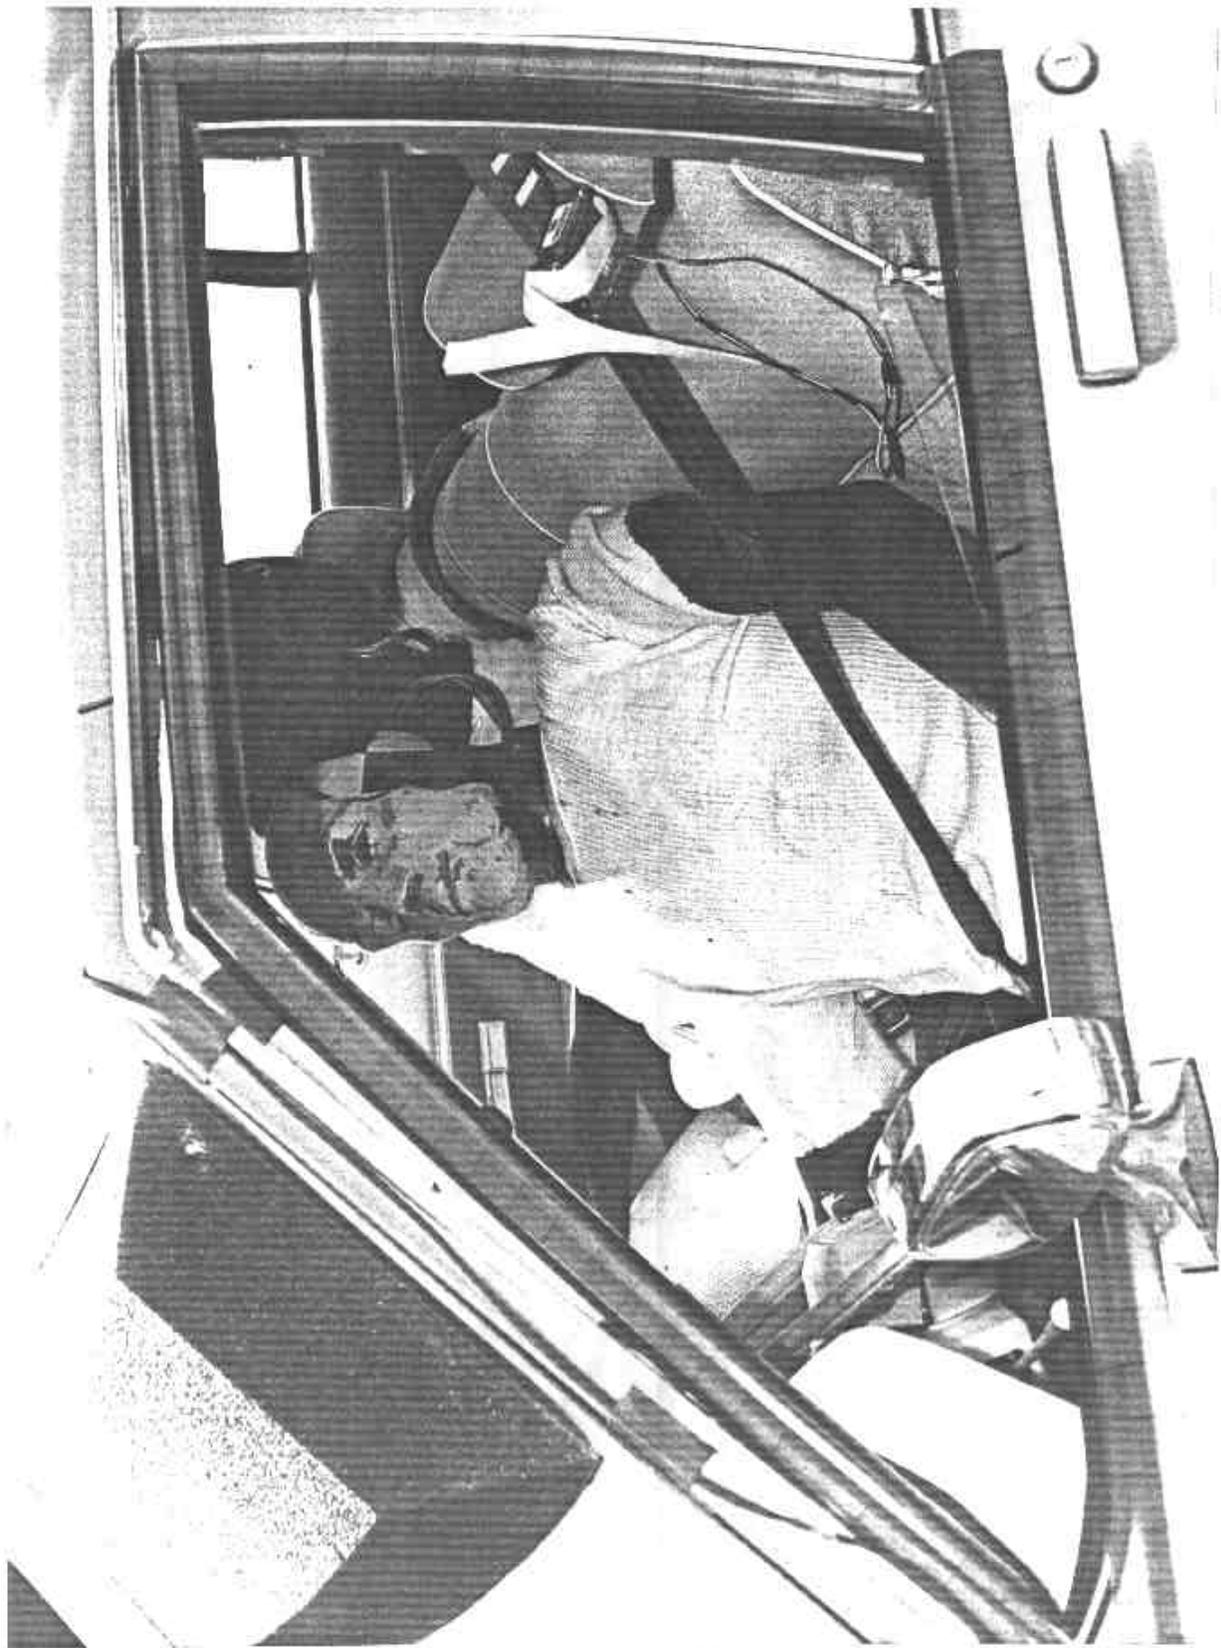
FIGURE A-21 POST-TEST DRIVER POSITION VIEW

The driver's head struck the upper steering wheel and center hub. The femurs contacted the underside of the dash panel. The driver satisfied all FMVSS 208 - Injury Criteria with a HIC of 881.9, maximum chest deceleration over 3 milliseconds of 41.7 g's, and femur loads of 650 and 675 pounds. Belt spoolout as measured by the transducer and film analysis was 2.25 inches and belt stretch was .325 inches per foot as measured between the retractor and "D" ring.
